Re: Notice of Violation
Compliance Evaluation Inspection
WID 000 000 356

SITE NAME: WM MERCURY WASTE, INC.
EPA ID NUMBER: WIR 000 000 356
ADDRESS: 21211 Durand Avenue, Union Grove, Wisconsin 53182-9711
DATE OF INSPECTION: February 14, 2013
EPA INSPECTOR: Cindy Dabner
Environmental Scientist

Attachment A
Photographs for WM Mercury Waste, Inc. RCRA CEI
WID 006 097 281
February 14, 2013

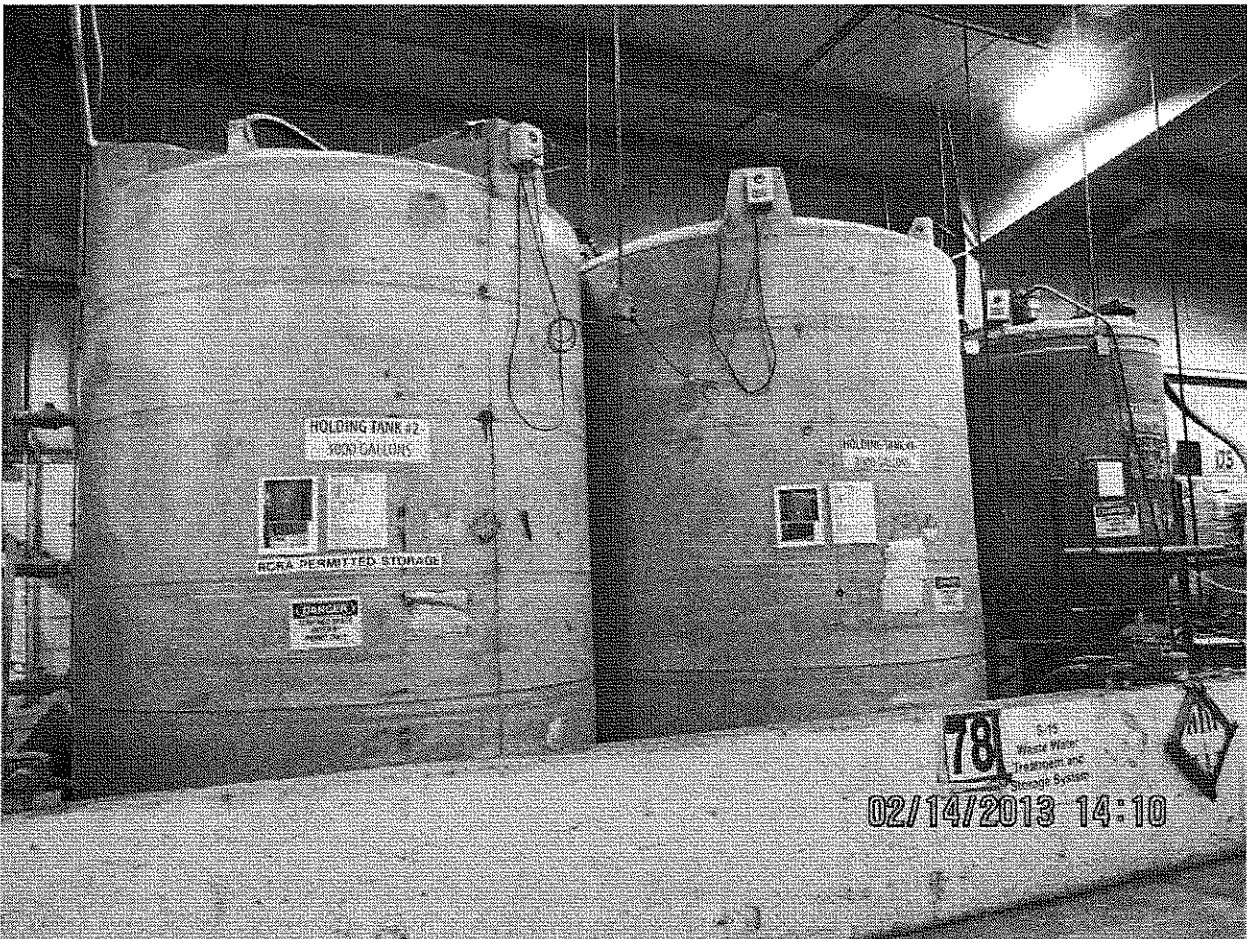
Photograph: #6

The inspection moved to the West Building S-15. The inspector observed Processing Tank #1 and #2 (each with a capacity of 500 gallons) and Holding Tank#1 and #2 (each with a capacity of 3000 gallons) S-15 of the West Building. The tank system includes a secondary containment

system that is designed to contain a volume of 3000 gallons. The tanks are considered to be a new tank systems since they were installed after March 1, 1991. The tanks were observed with a sign noting a RCRA Permitted Storage Tank and was marked as hazardous waste. No cracks or gaps were observed in the secondary containment system. No waste or liquids were observed within the secondary containment at the time of the inspection. See Photograph #6 through #9.

Description: Holding Tanks #and #2 with Processing Tank #1 located in the S-15 of the West Building

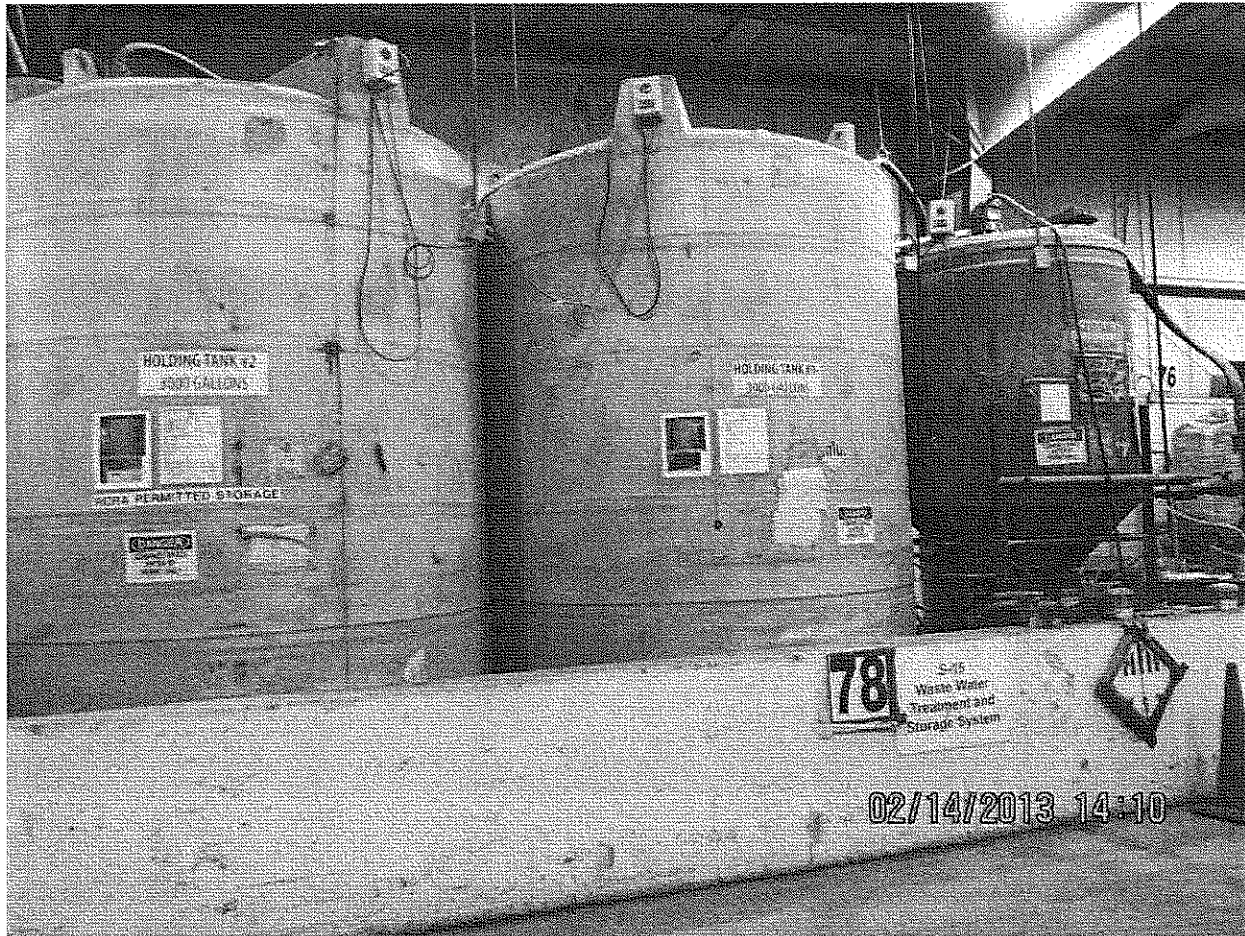
Photograph: #7

Description: Holding Tanks #1 and #2 and Processing Tanks #1 located in the S-15 of the West Building

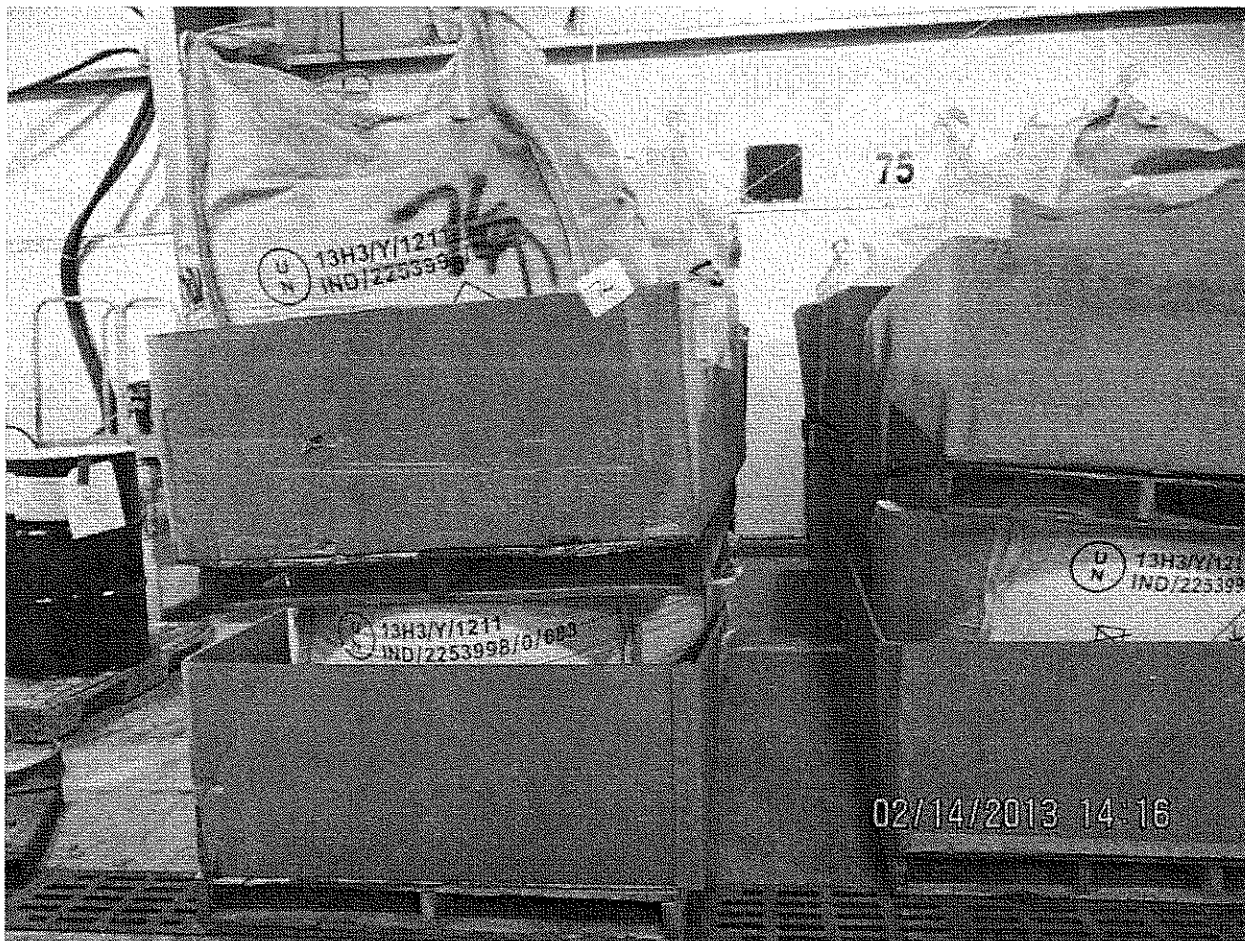
Photograph: #10

The inspection continued in the West Building, specifically areas marked as #74-76). In this area, the inspector observed super sacks stored in cubic yard boxes that were slightly tilted, but allowed adequate aisle space. The inspector also observed several boxes and 55-gallon drums that were properly marked as hazardous waste with hazardous waste codes and accumulation start dates along with DOT shipping information and UN number. See Photograph #10 through #12.

Description: Super sacks storing hazardous waste contained in cubic yard containers in the West Building

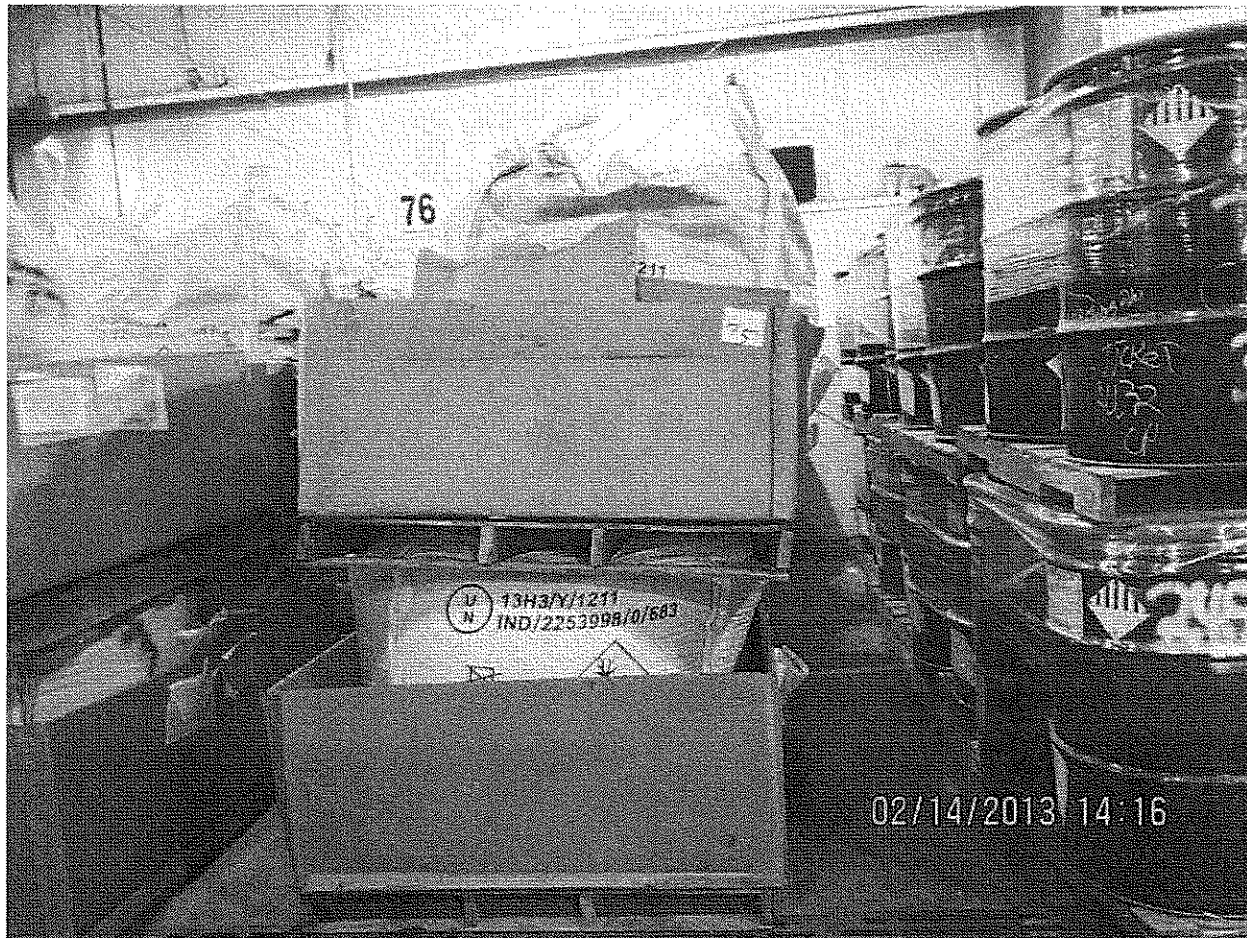
Photograph: #11

Description: 55-gallon drums and super sacks storing hazardous waste contained in cubic yard containers located in the West Building

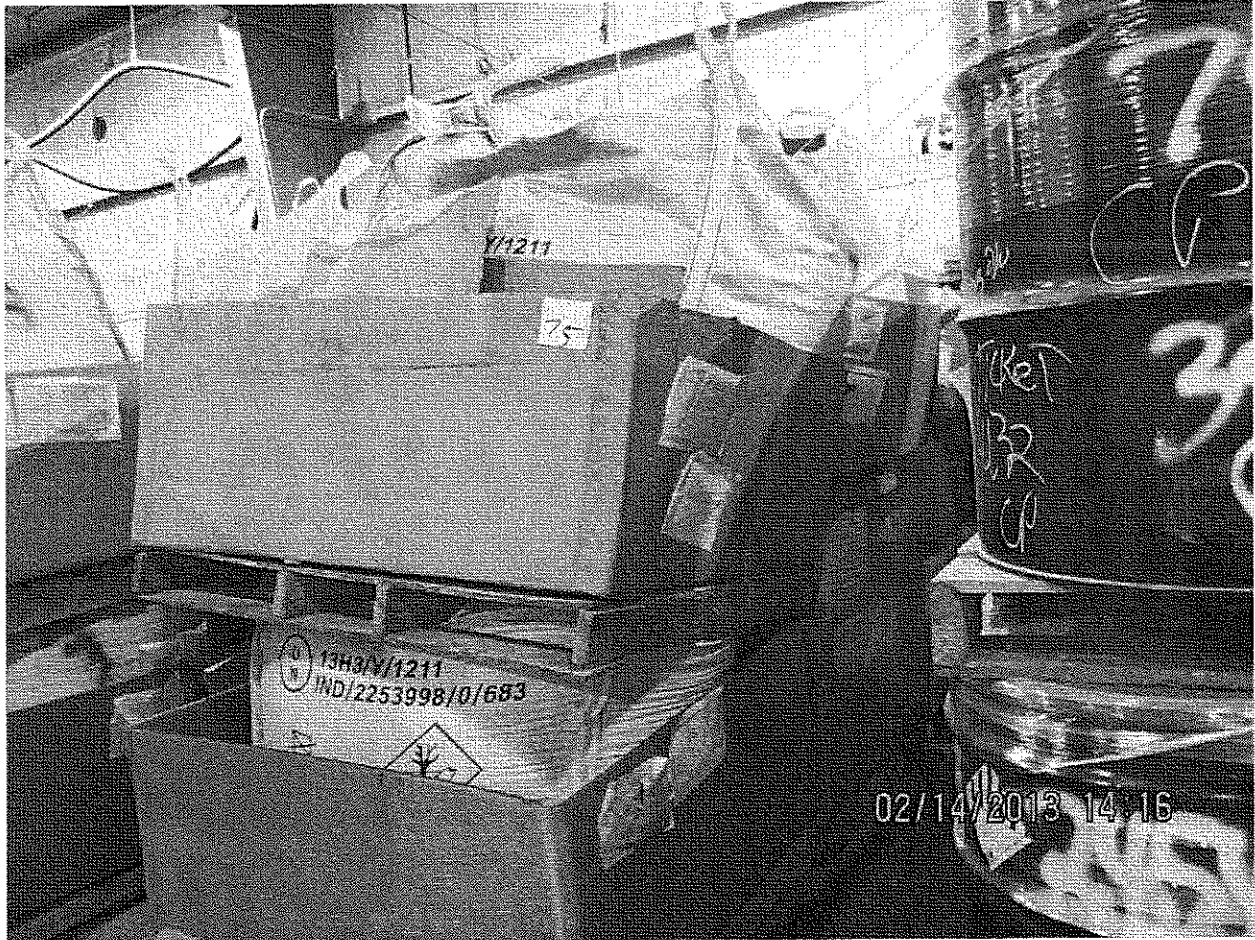
Photograph: #12

Description: Super sacks storing hazardous waste contained in cubic yard containers in the West Building

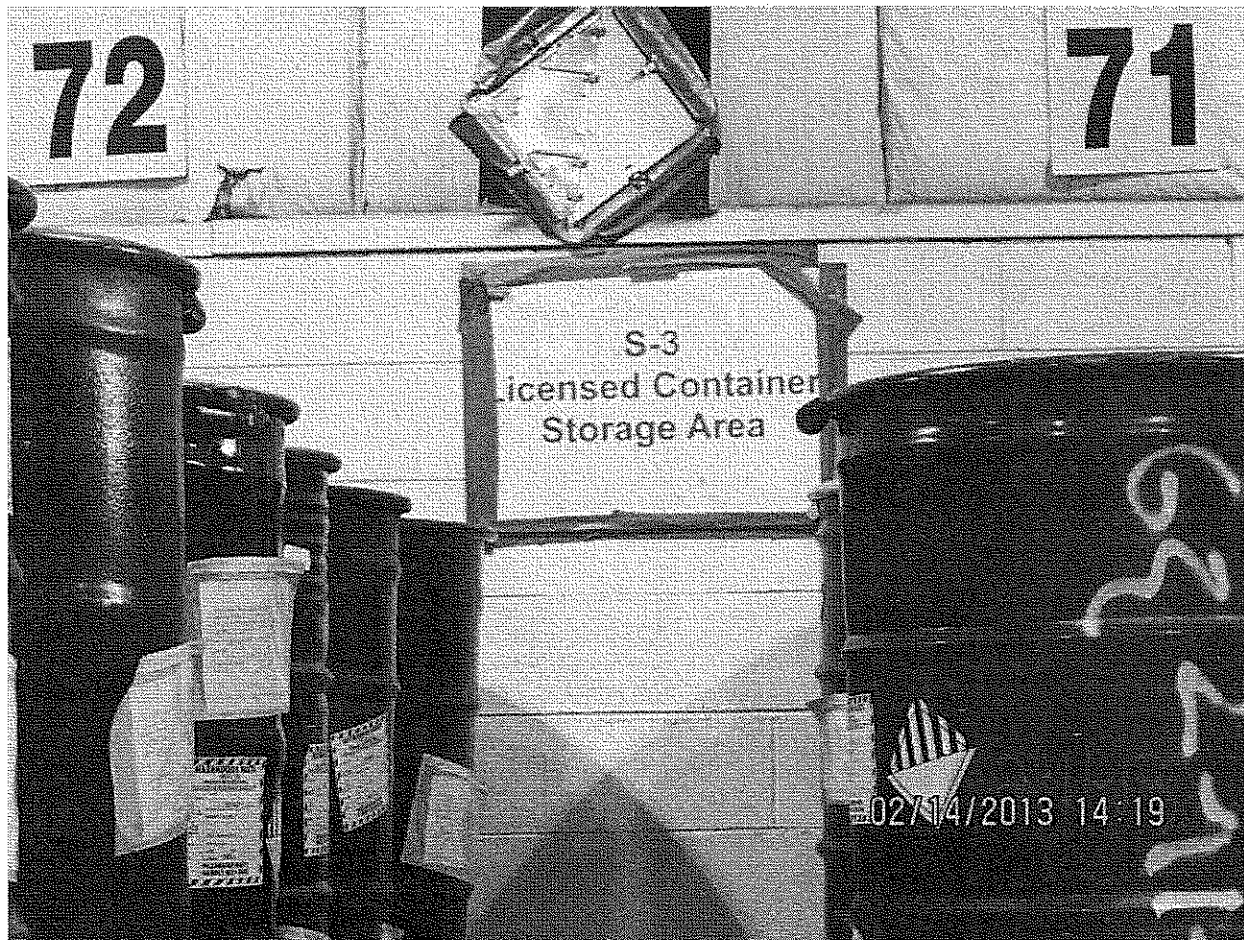
Photograph: #13

At S-3 of the West Building, the inspector observed a Licensed Container Storage Area holding over twenty 55-gallon drums containing hazardous waste. See Photograph #13. The inspector observed each of the drums. Each of the drums were properly marked as hazardous waste with hazardous waste codes and accumulation start dates including DOT shipping information and UN numbers.

Description: 55-gallon containers located in the S-3 Licensed Container Storage Area

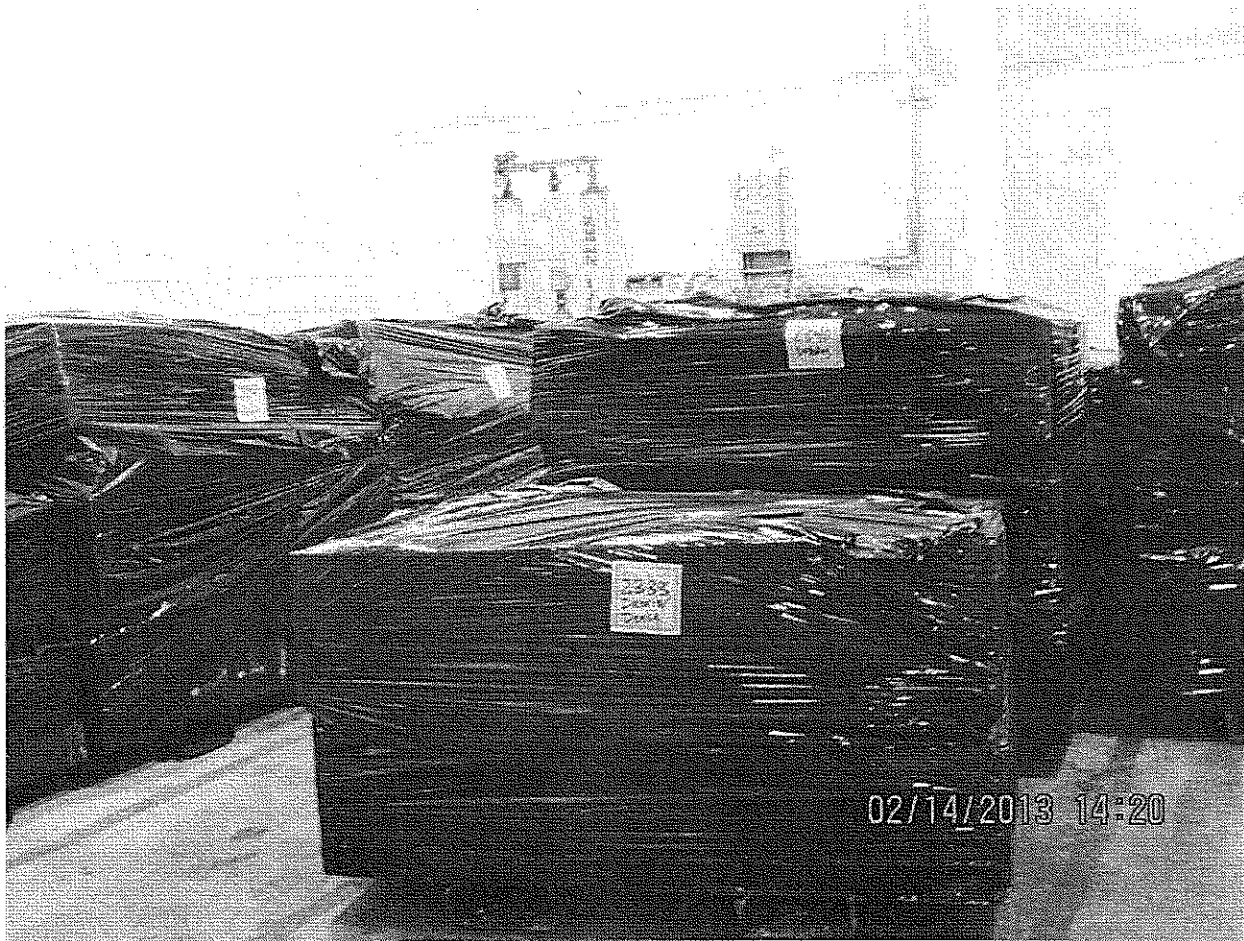
Photograph: #15

The inspection moved to S-2 of the West Building. The inspector observed a Licensed Container Storage Area, S-2, storing over twenty plastic wrapped containers on pallets marked as waste pending analysis and labeled as hazardous waste. See photograph#14-15.

Description: Waste Pending Analysis with Hazardous Waste Codes

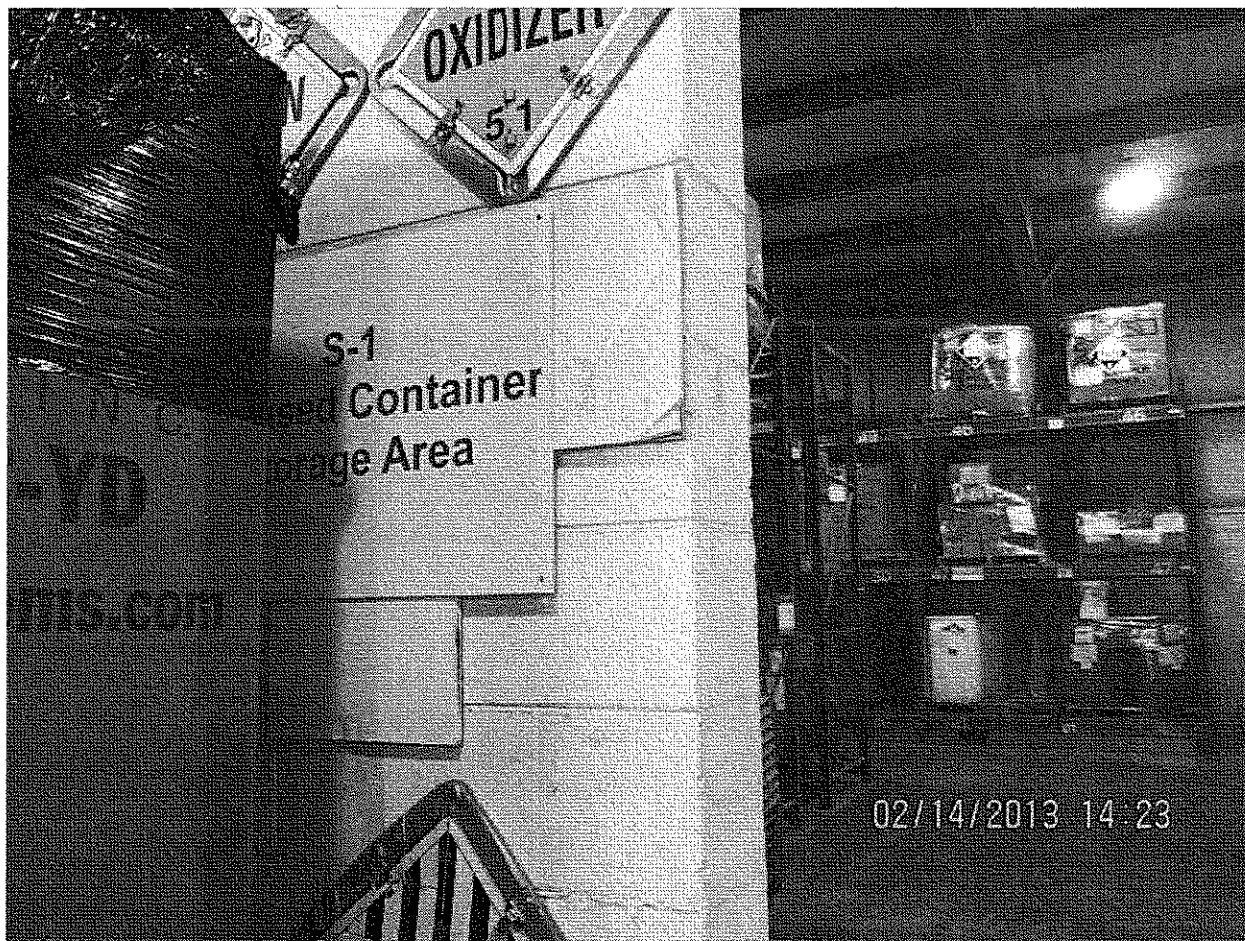
Photograph: #16

In the License Container Area S-1 of the West Building, the inspector observed over fifty containers and drums storing hazardous waste. Each of the of the containers and drums were observed properly marked with the words hazardous waste, hazardous waste codes and accumulation start dates along with DOT shipping information. See photographs#16 and #17.

Description: S-1 Licensed Container Storage Area

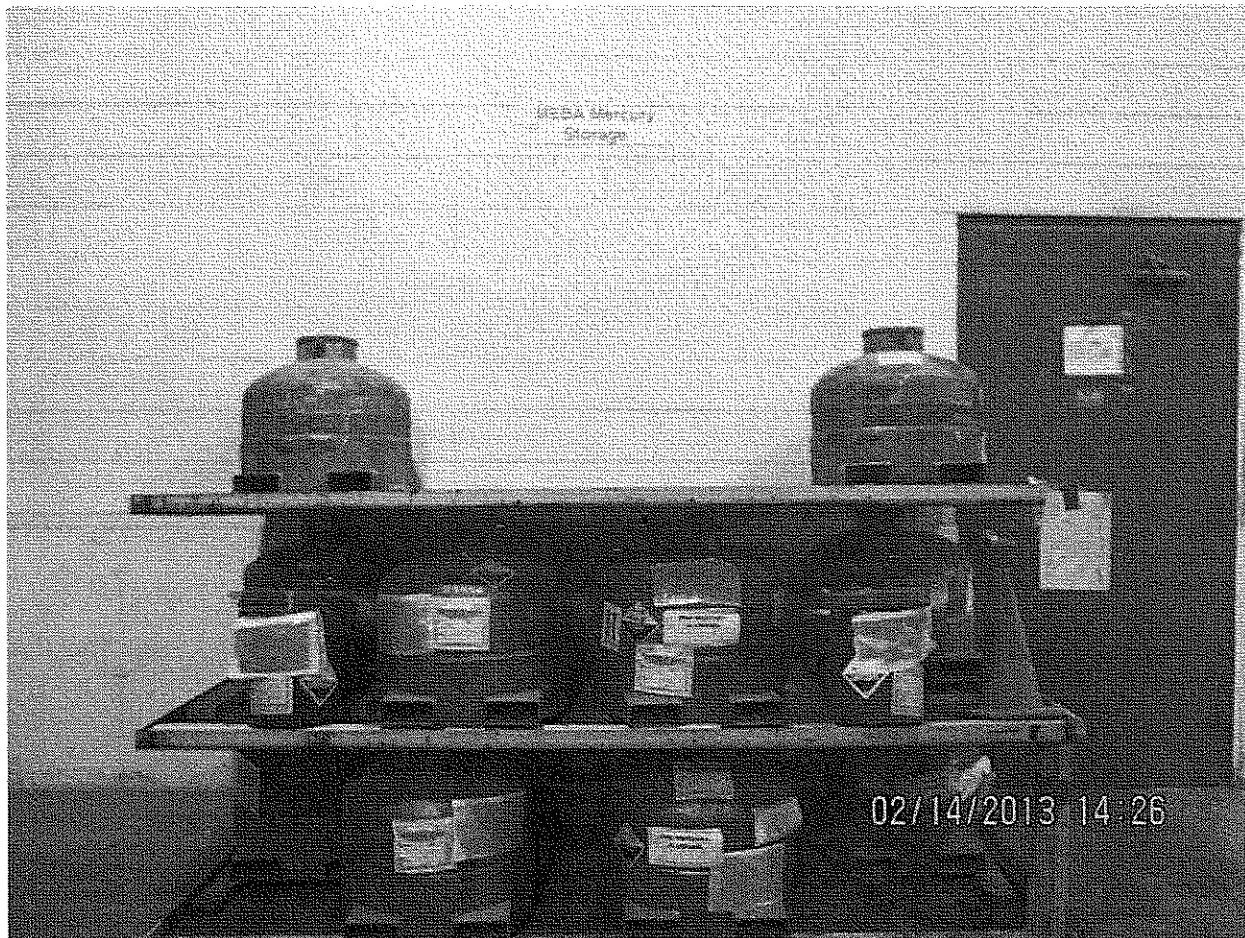
Photograph: #19

Additionally, the inspector observed a Mercury Export Ban Act (MEBA) Storage Area. At the time of the inspection, WMMW received authorization from the Wisconsin Department of Resources (WDNR) to store elemental mercury that is subject to MEBA for more than one year provided WMMW complies with certain conditions. At the time of the inspection, the inspector do not observe any concerns with WMMWI complying with the conditions outlined in the storage authorization, dated November 29, 2012, Subject: Request for Relief on the One Year Storage Limitation for Elemental Mercury. See Photograph #17 through #19.

Description: MEBA Mercury Storage Area

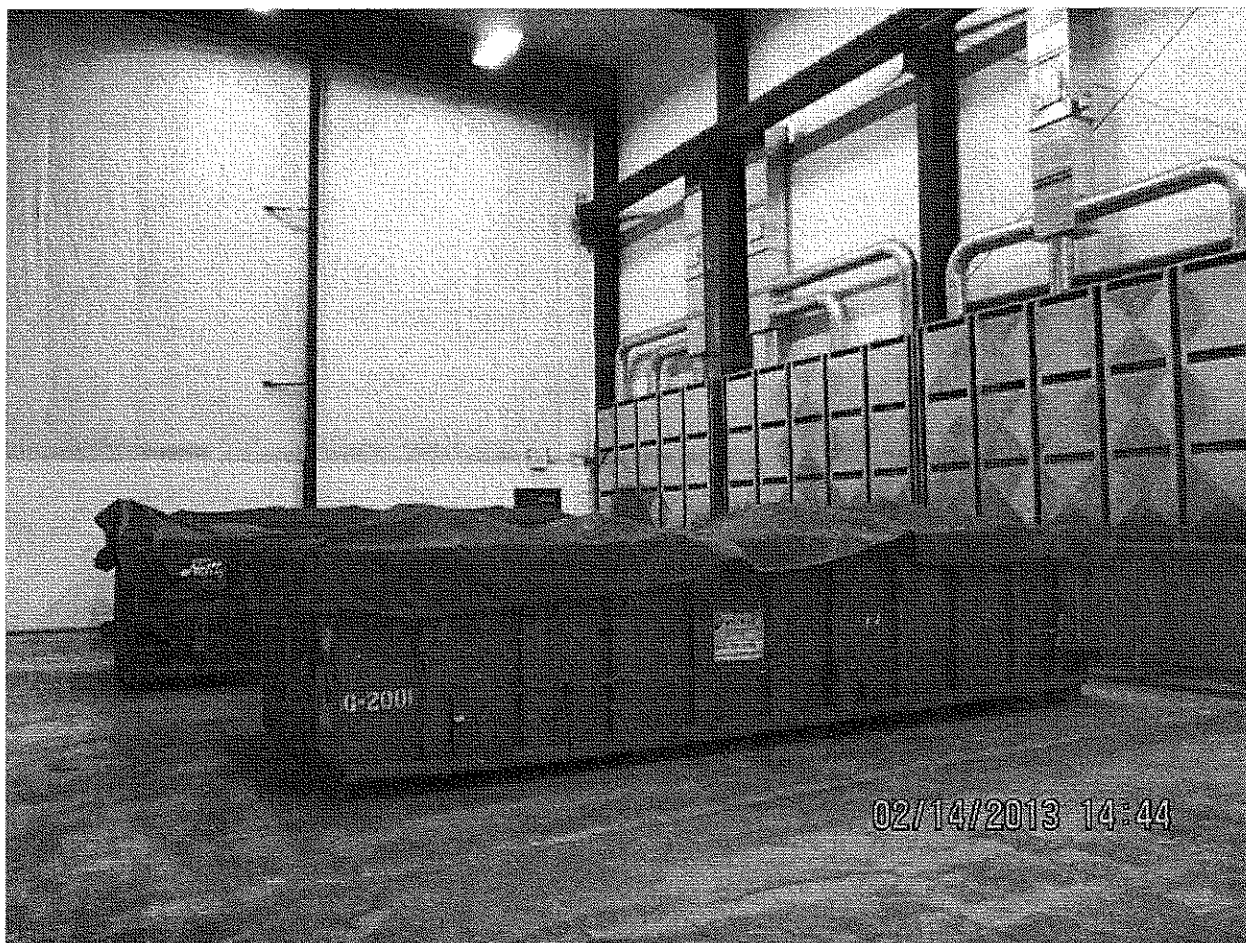
Photograph: #20

The inspection continued to an area of the West Building where two roll-off cubic yard box containers with a capacity of approximately forty cubic yards. The inspector observed each of the two roll-off boxes with covered containers. Each of the containers were properly marked with hazardous waste codes and accumulation start dates along with the DOT shipping information and UN number. See Photograph #20. However, the inspector did not observe a sign or placard posted to indicate the licensed storage unit name. At the time of the inspection, a

Description: Roll-Off Box Storing Hazardous Waste Area

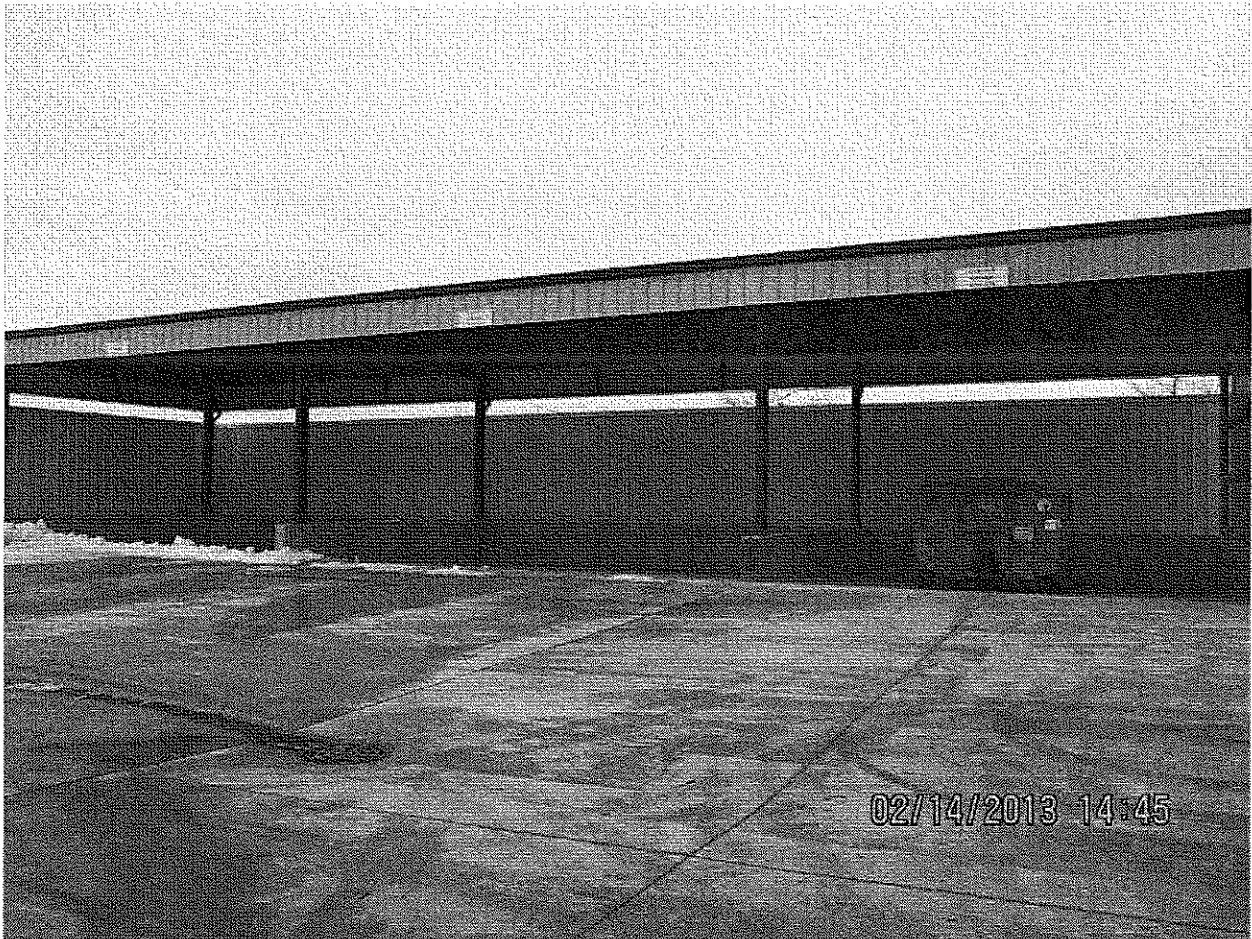
Photograph: #22

At S-14 of the Bulk Storage Shed, the inspector observed an empty roll-off box that was covered. See Photograph #22-23.

Description: Licensed Bulk S-14 Shed with a covered roll-off box

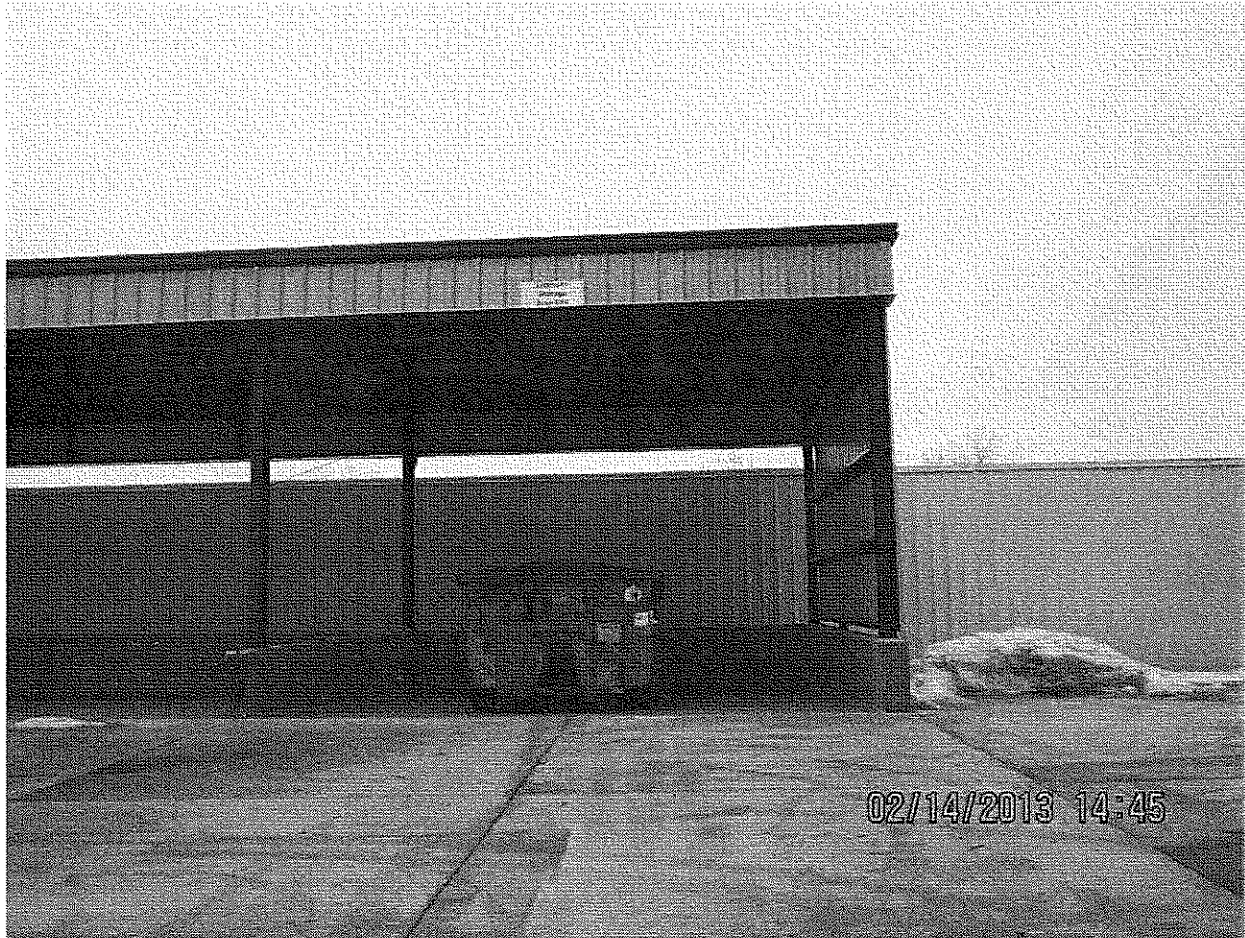
Photograph: #23

Description: Closer picture of Licensed Bulk Shed S-14 with a covered roll-off box

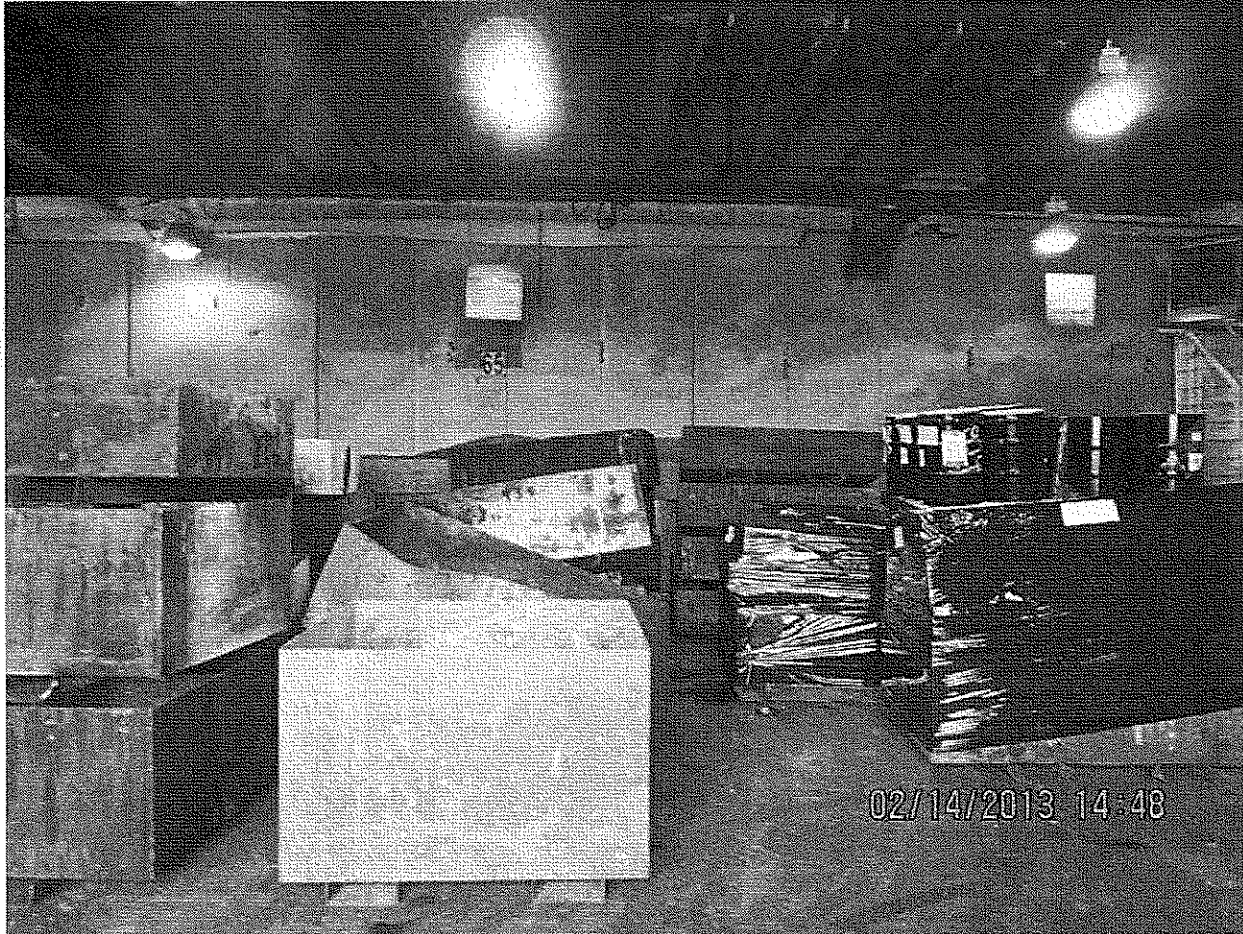
Photograph: #25

In the Waste Roll-off Storage Building, Area #65, the inspector observed approximately twenty 55-gallon drums and four containers boxes, and several 30 gallon containers labeled as universal waste. Each of the containers were observed properly marked with accumulation start dates or marked as waste pending analysis. See Photograph #24-27.

Description: Waste Pending Analysis with Hazardous Waste Codes and 55-Gallon Drums storing Hazardous Waste

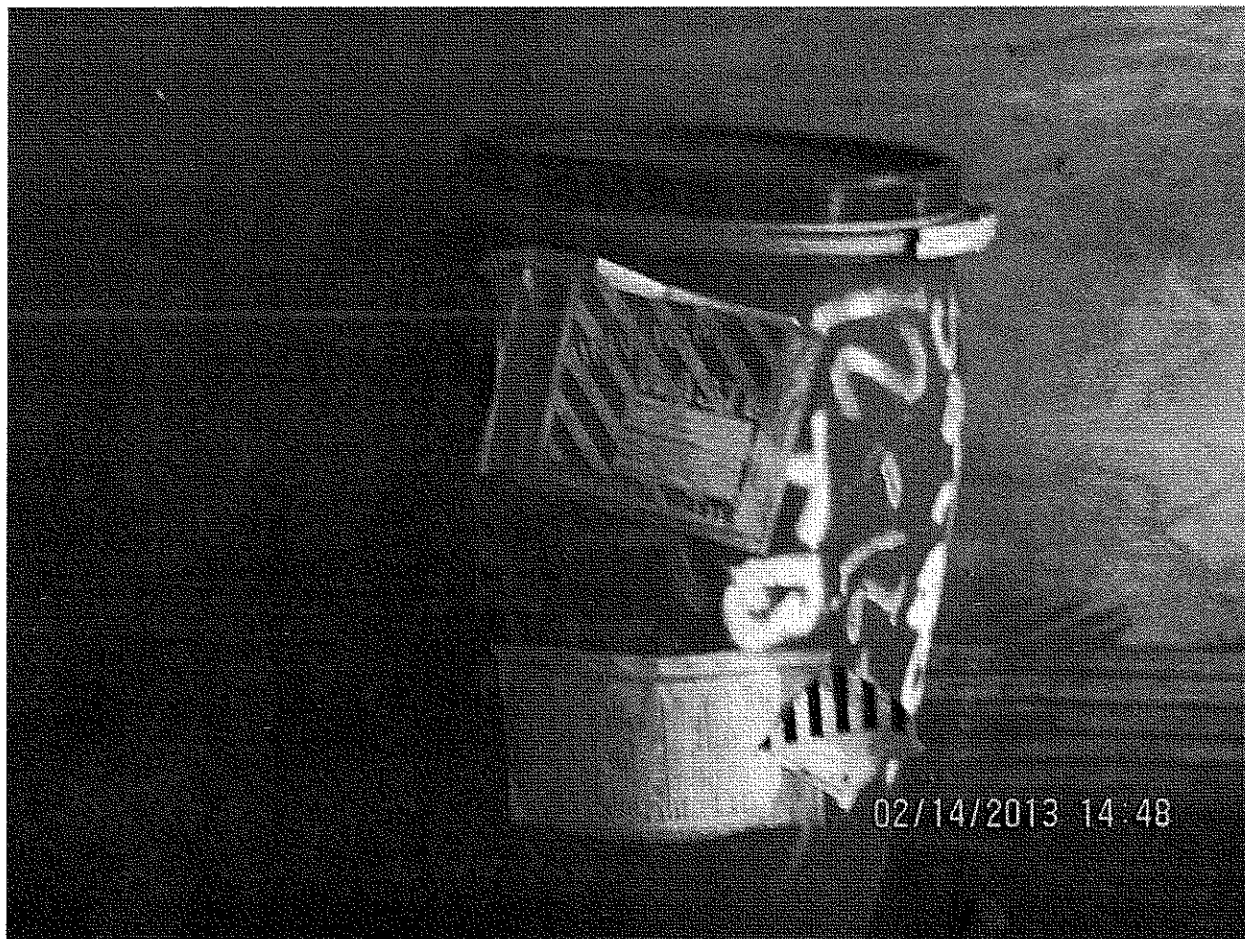
Photograph: #26

Description: Universal waste stored in a container located in the waste Roll-off Storage Building

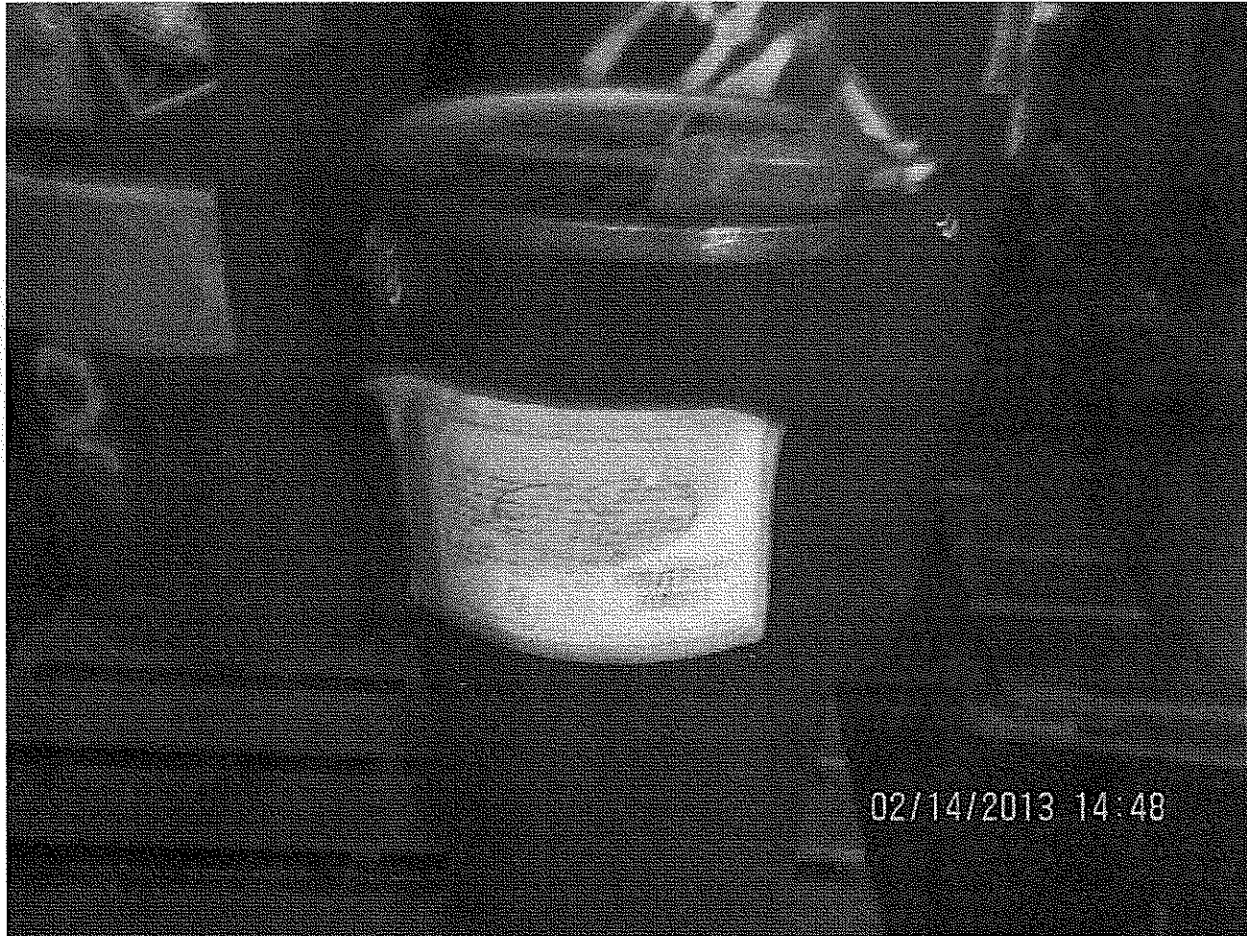
Photograph: #27

Description: Universal Waste located in the Waste Roll-Off Storage Building

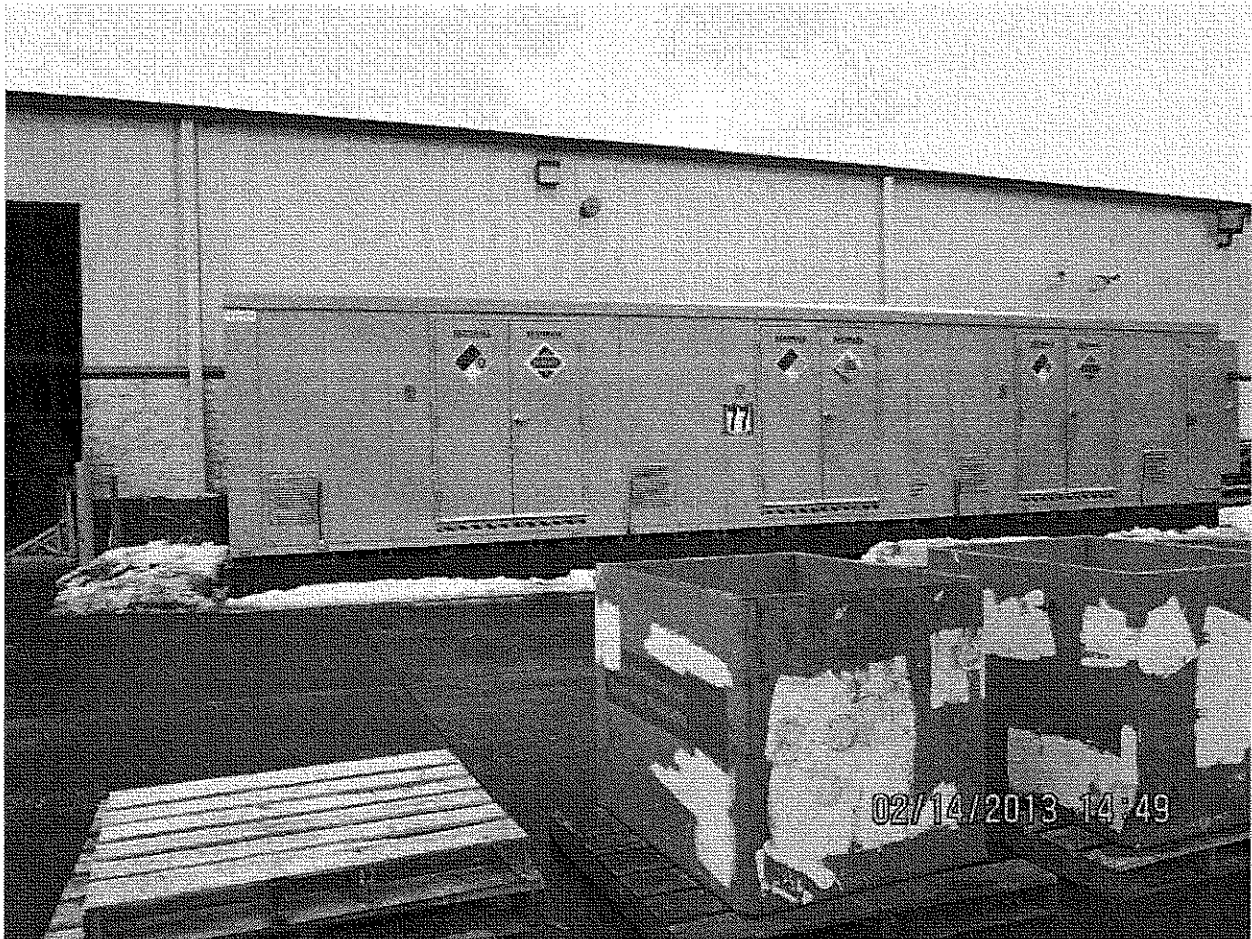
Photograph: #28

The inspection continued to the Licensed Flammable Storage Shed, S-6, located in the Receiving Yard. At the time of the inspection, no hazardous waste was observed in the Shed S-6. See photograph #28.

Description: S-6 Licensed Flammable Storage Shed Located in the Receiving Yard.

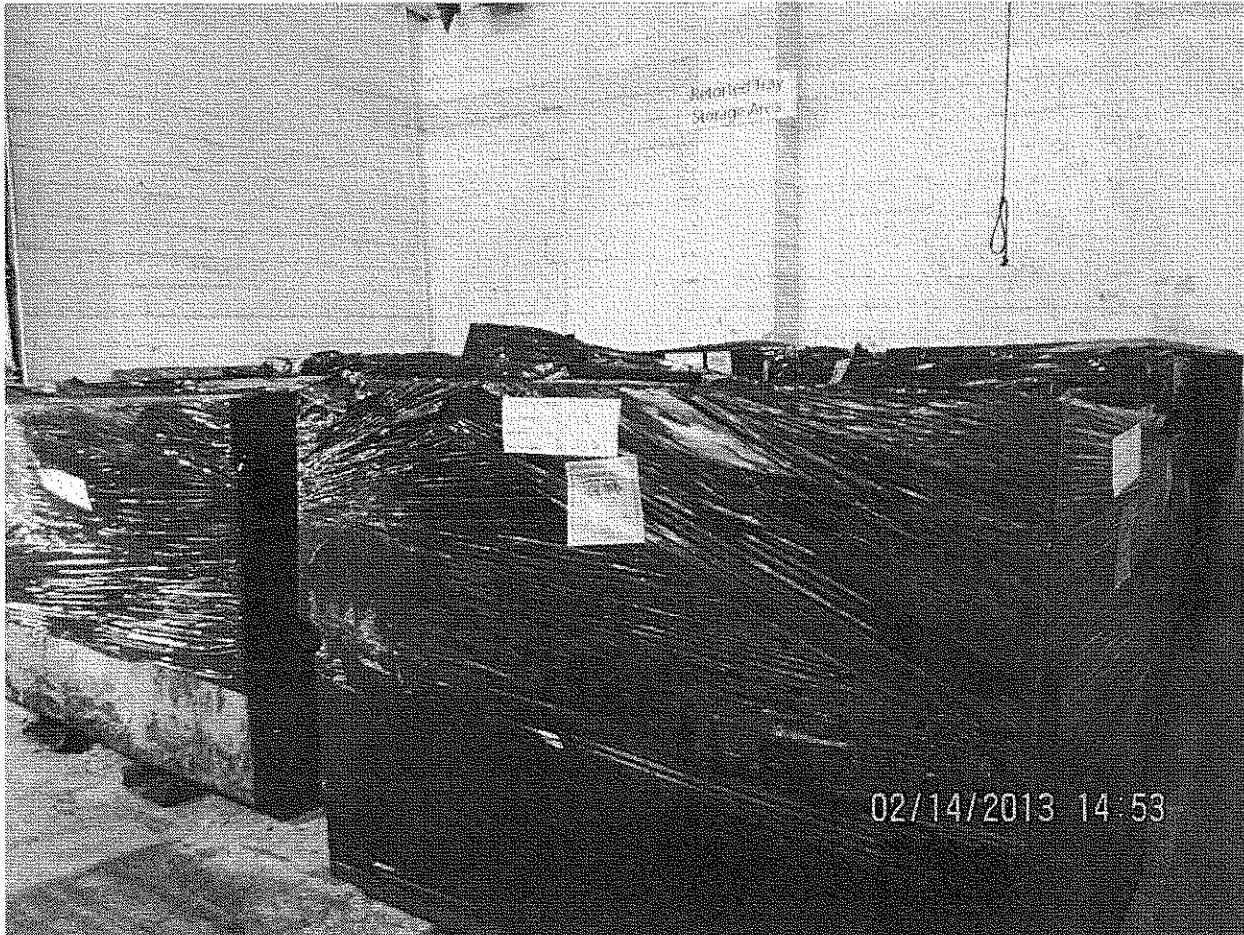
The inspection moved to the Retorted Tray Storage Area where containers storing retort furnace trays. The trays containing hazardous waste were removed from the stationary retort ovens and were observed marked with the words, waste contents pending analysis. The date the waste was sampled was also provided as required of the hazardous waste treatment and storage license. See photograph #30-33.

Photograph: #33
Name of Photographer: Cindy Dabner
Date/Time of Photograph: February 13, 2013
Site Location: 21211 Durand Avenue, Union Grove, WI 53182
Description: Waste Pending Analysis located in the Retorted Storage Area

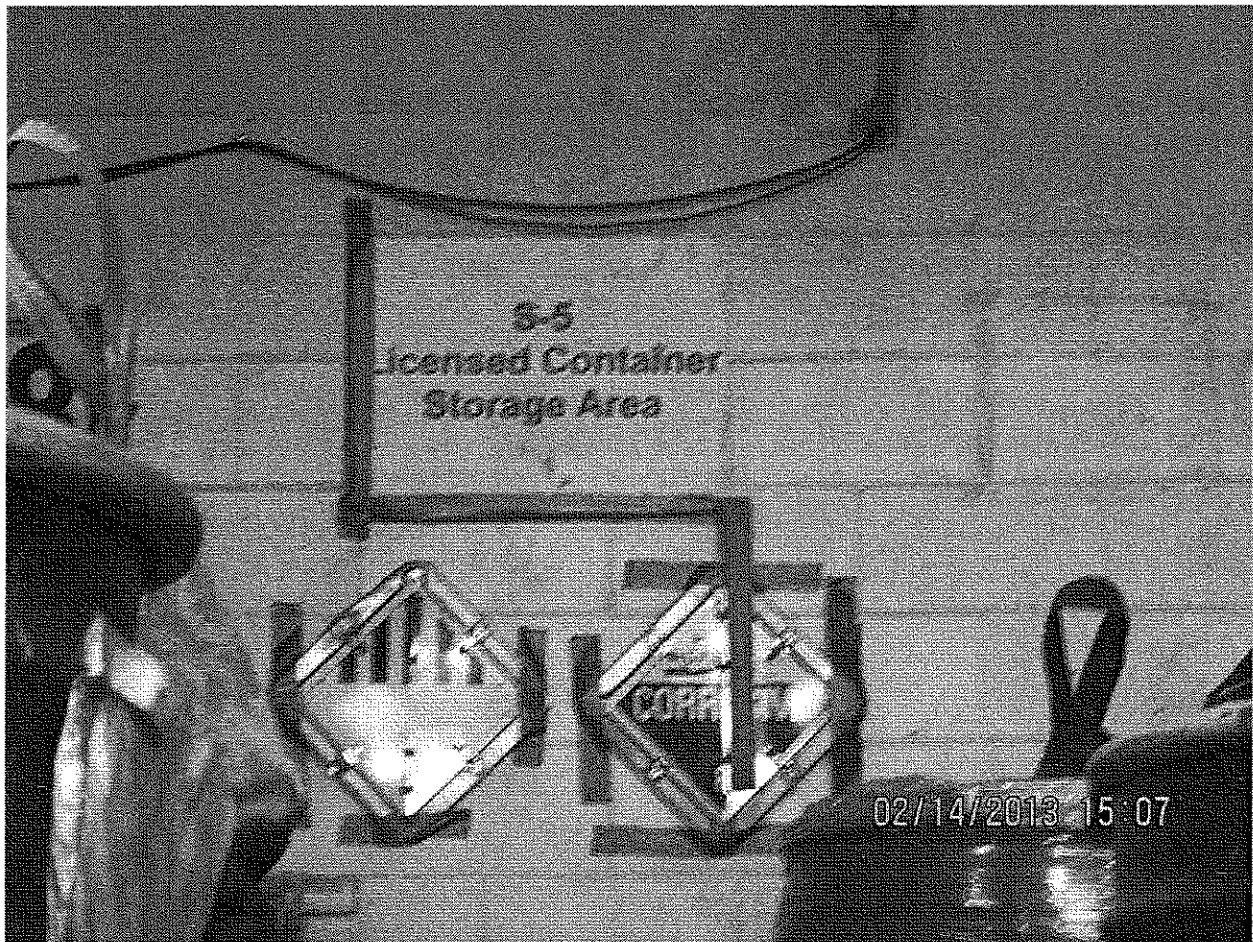
Next the inspection continued to S-5 of the East Building. At this location, at least 50 drums and containers of hazardous waste and universal waste were observed at this licensed storage area location. The inspector observed each of the drums. Each of the drums were properly marked as universal waste with accumulation dates or hazardous waste with hazardous waste codes and accumulation start dates along with DOT shipping information. See Photograph #34 -35.

Photograph: #34
Name of Photographer: Cindy Dabner
Date/Time of Photograph: February 13, 2013
Site Location: 2188 Church Street, East Troy, WI 53120
Description: S-5 Licensed Container Storage Area
